**NATIONAL OXIDIZING POOL CHEMICALS STORAGE
FIRE TEST PROJECT**

David P. Nugent
Schirmer Engineering Corp.

David Sheppard
Daniel R. Steppan
Underwriters Laboratories Inc.

NATIONAL
FIRE PROTECTION
RESEARCH FOUNDATION

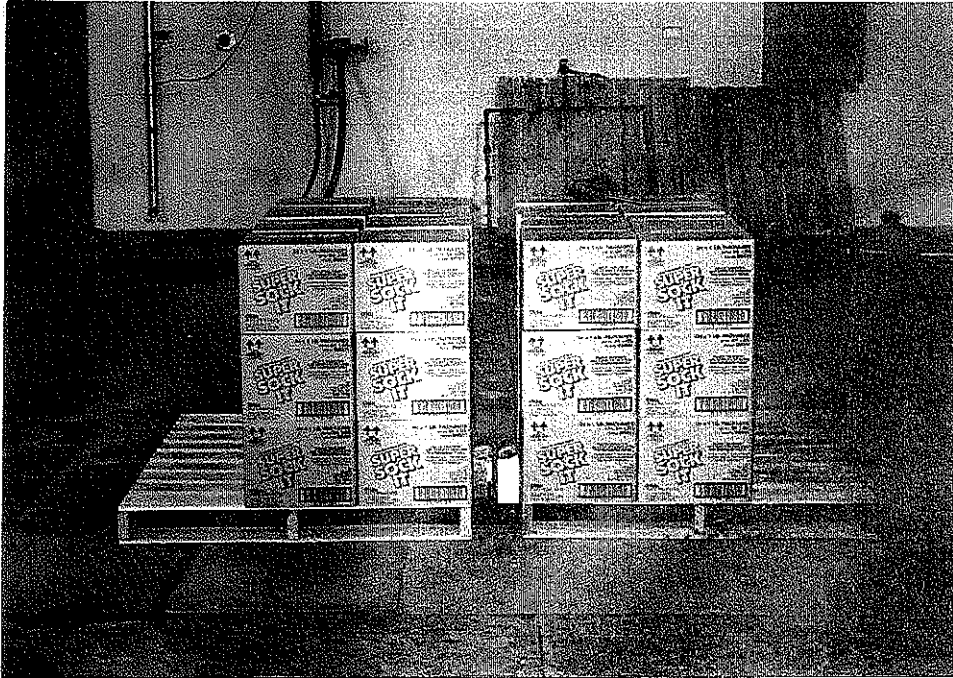
Photo 1
Free-burn Test No. 2
Configuration and
Ignition Location

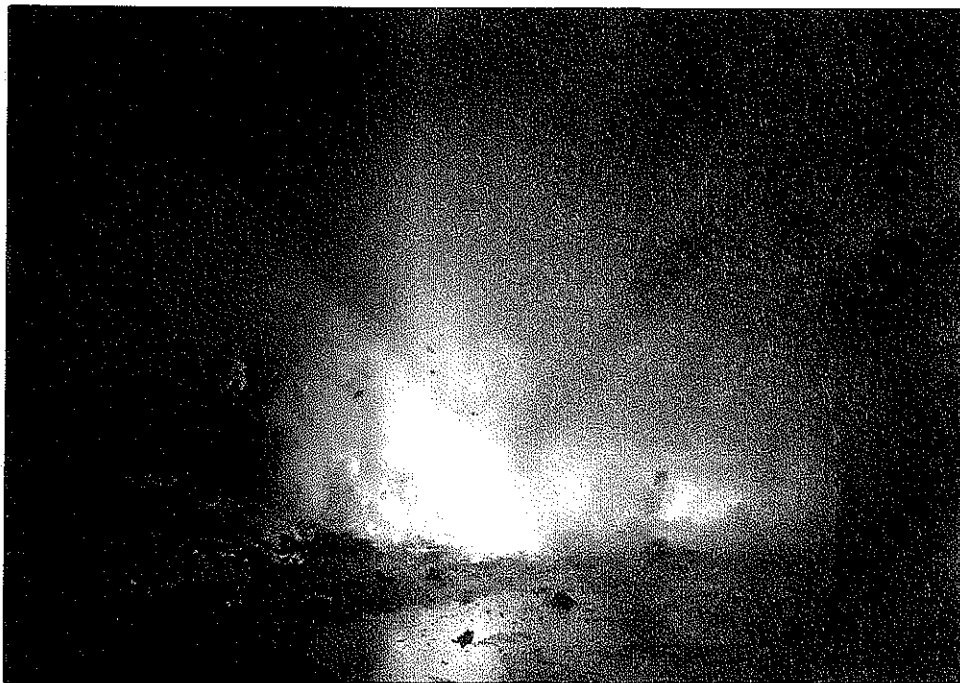
Photo 5
Free-burn Test No. 3
During Test

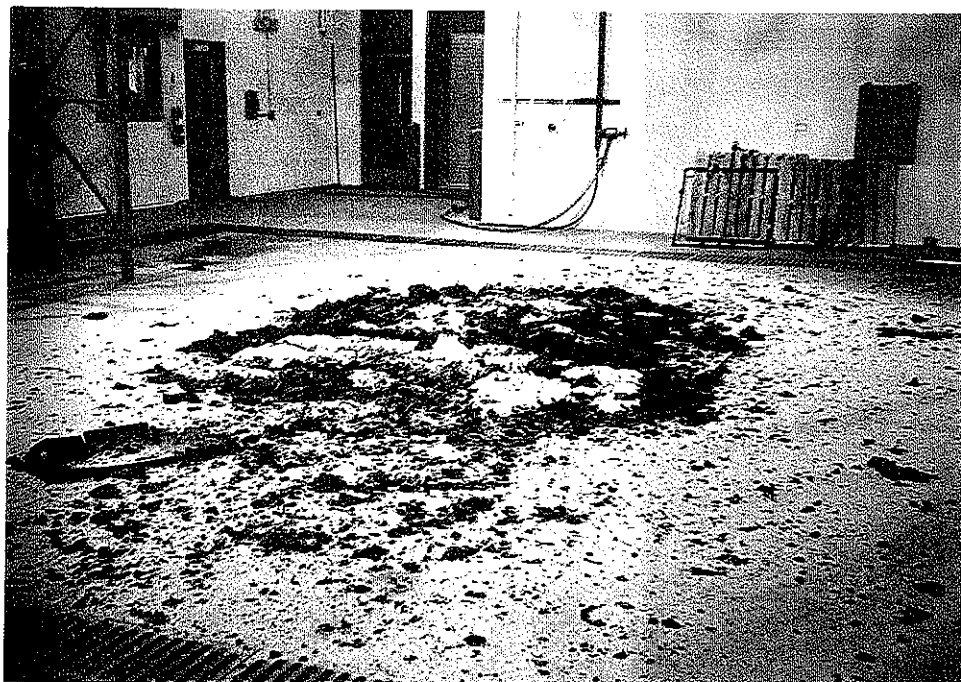
Photo 6
Free-burn Test No. 2
Post Test

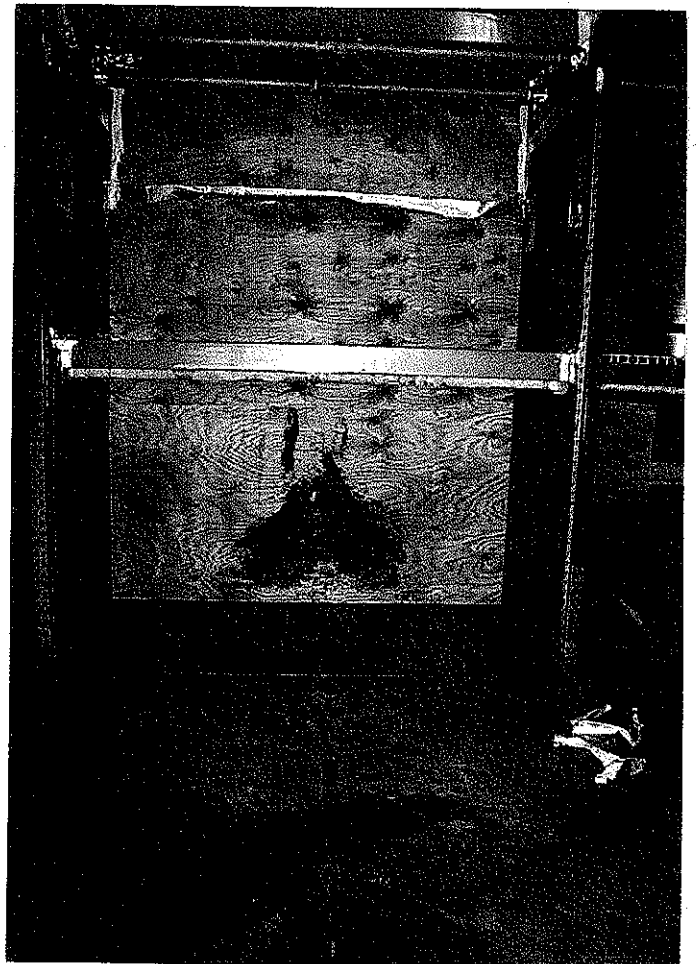
Photo 10
Sprinkler Test No. 11
Post-Test Damage to
Plywood Test Enclosure
(No burn through)

Sprinkler Test 11 was terminated early by having the backup water deluge system activate in order to suppress the fire. The plywood test enclosure showed signs of charring to the lower level (see Appendix F, Photo 10) rear wall after the test, however no breach was noted.

Sprinkler Test 11 demonstrated significant product involvement, however due to the deluge system being activated, sprinkler system suppression of the resulting fire was not demonstrated. There was chemical product remaining in the breached containers after the test. Charring of the test enclosure's rear wall of the lower tier was noted (see Appendix F, Photo 10). No breach of the test enclosure was noted.

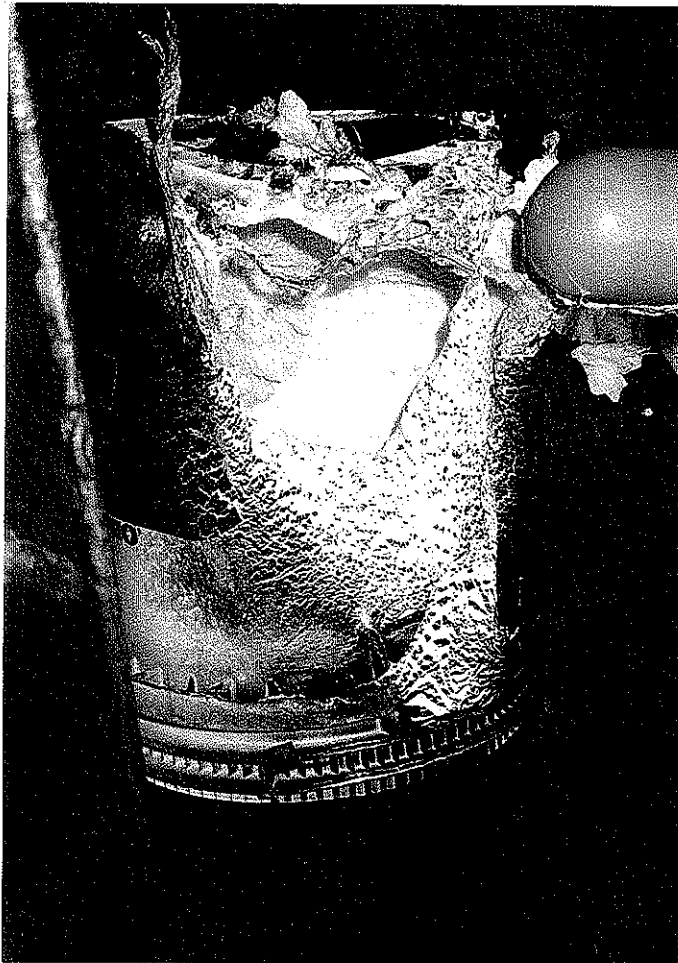
Photo 11
Sprinkler Test No. 1
Post Test Damage
to Lower Bucket

- (7) It was observed during Sprinkler Tests 1 and 2, the plastic buckets had breached on the bottom due to fire impingement and eventual burn-through of the bottom of the commodity container. This caused commodity to spill on the floor underneath the pallet and caused additional damage to the commodity.

Photos of damage assessment appear in Appendix F, Photos 11-14.
